Lower Swell - War Memorial Project

Location: Lower Swell, Gloucestershire

Pre Clean Inspection

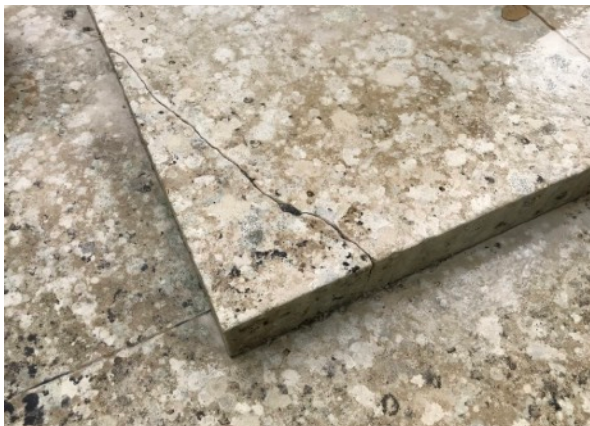
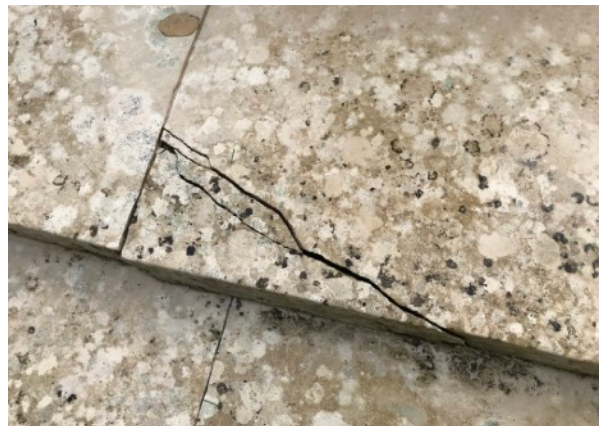
The base of the memorial has two cracks on the 3rd tier/ upper step of around 30cm long which run across the corners of two separate stones (pictures 1 & 2). Both cracks have run completely through the stone work meaning the corner pieces are now detached but still in place. Stone work repairs would help prevent further damage from water ingress/ frost.

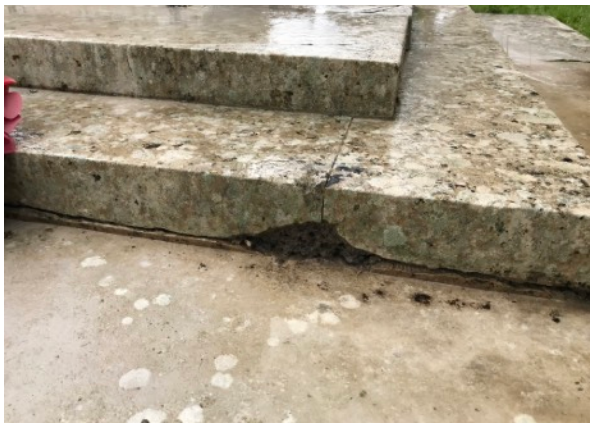
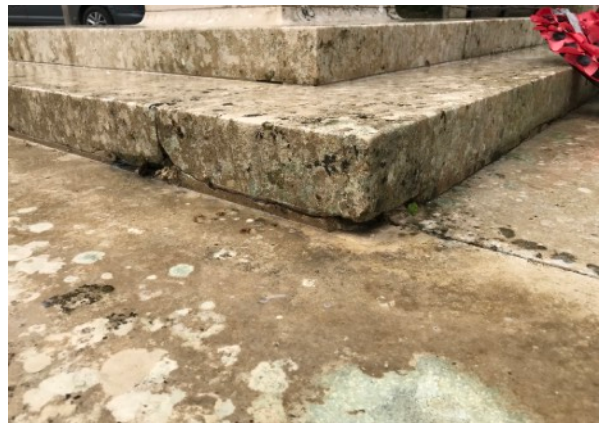
The 2nd tier/ step has two minor chips in the lower edge of the stone work that sits against the 1st tier step (pictures 3 & 4). While these chips are minor the pointing around each of them appears to be loose allowing further damage from water ingress/ frost in the future.

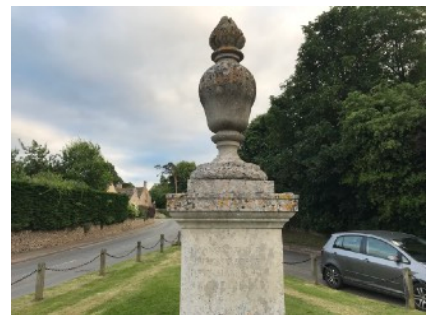
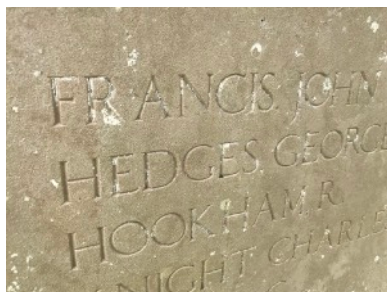
The flame urn at the top of the memorial had the majority of the moss scraped out using scrapers and was then brushed down to remove as much organic build up as possible without extensive scrubbing due to the delicate nature and design and stone work.

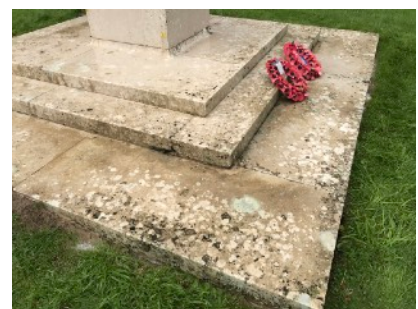
Cleaning project before and after pictures...

The base/ steps around the bottom of the memorial where brushed down, scrapped where required the washed down with the soapy solution to remove any build up of dirt and traffic film that had adhered to the horizontal surfaces. Minimal black lichen staining and other organic matter that was well adhered to the stonework in this section was removed to an acceptable level which balances the extensiveness of cleaning with leaving the memorial with its aged look and heritage.
